HLARA RADIOGRAM

The Quarterly Publication of the Heartland Antique Radio Association, Inc.

October 2006 Edition

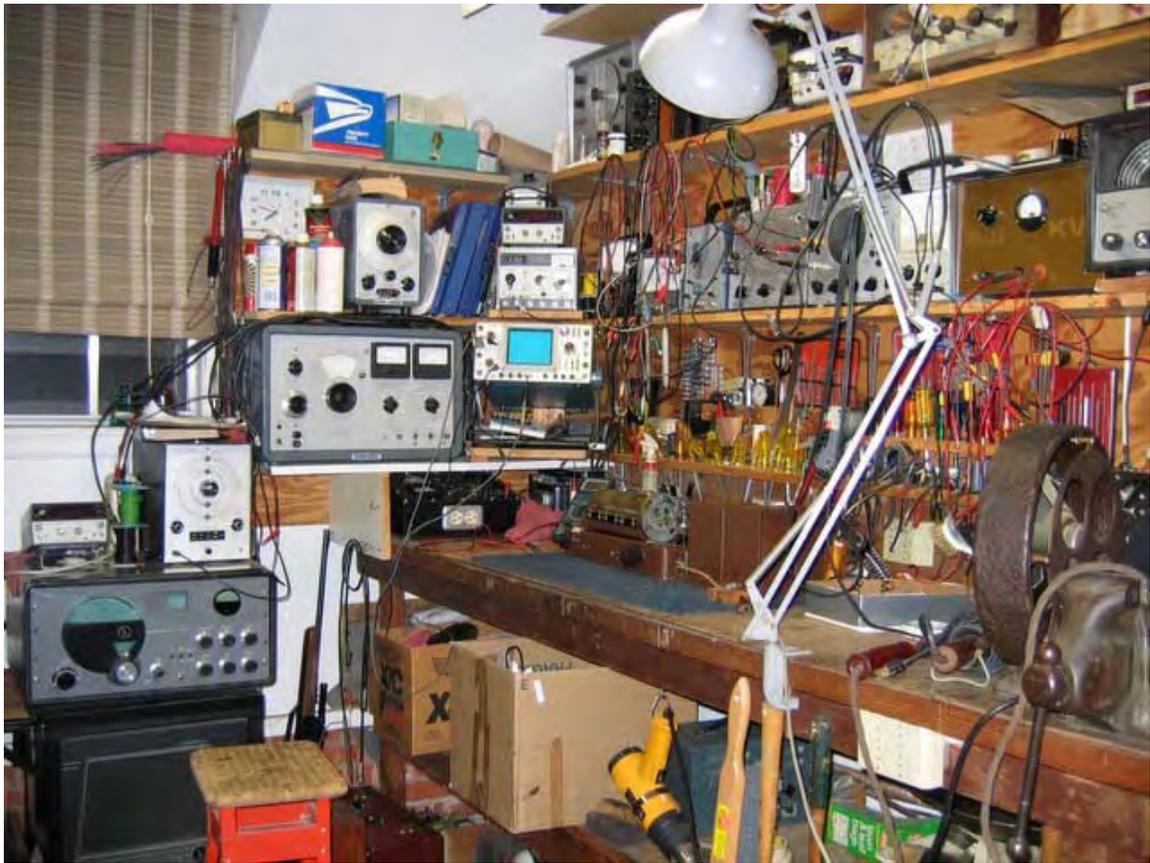
Figure 1: Bob's workbench side view

Each issue I will be seeking out a member's workbench for a feature article. For the first article, I'm going to cover Bob Shindhelm's workbench. Bob was the first antique radio collector I met in the Tulsa area. As a ham operator, I was immediately impressed with all the equipment on Bob's workbench. See Figures 1 and 2 for nice views of his test equipment and work area.

Bob's work area is located in his garage, which is pretty well consumed with the hobby, including a radio repair workbench, a radio restoration and woodworking bench, and many shelves of radios and parts. He told me that the two workbenches were already in the garage when he purchased the house. Since then he has added shelves and storage areas, as well as all his test equipment and woodworking tools. He has also installed good lighting, power, tool and test lead holders, and a suitable work surface to work on the radios.

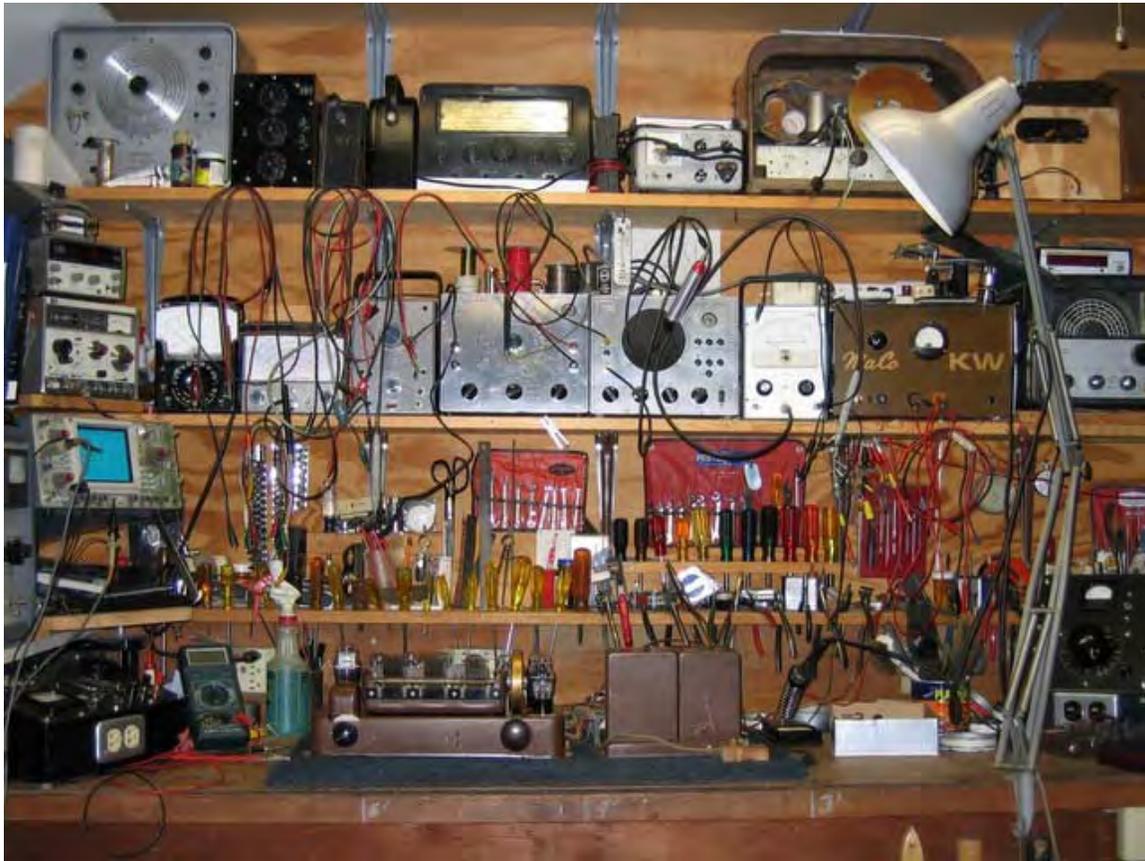
Figure 2: Bob's workbench front view

The key piece of test equipment in any radio shop is the signal generator, and Bob has a top of the line HP 606A generator that covers 50 KHz to 65 MHz. This signal generator has a perfect sine wave, accurate calibration and precise output control, with no signal leakage. Bob wrote an article that described how he acquired the signal generator from eBay in the February 2006 issue of *Antique Radio Classified (ARC)* magazine. As noted in the article, he needed to build a special heavy duty shelf to hold this unit. It can be seen near the middle of Figure 1 next to an oscilloscope, with a large gray front panel and two meters. Speaking of oscilloscopes, this is another handy piece of test equipment and he has a Tektronix 465B unit – another “standard” for the workbench.

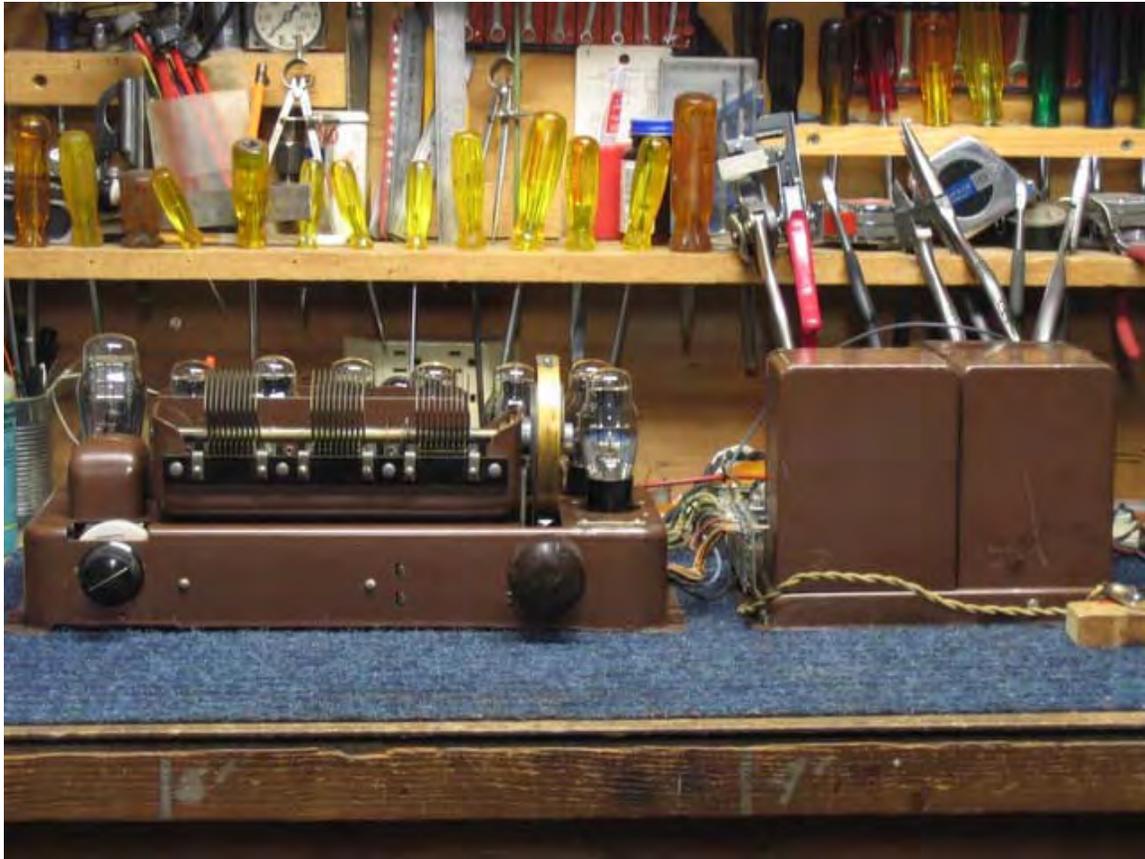
Figure 3: RCA Radiola 60 playing on the bench

A workbench is isn't complete without a radio, and on the night I stopped by Bob's house to take these pictures he had a very nice RCA Radiola 60 playing full force on the bench. This radio, along with a close up of many of his hand tools can be seen in Figure 3.

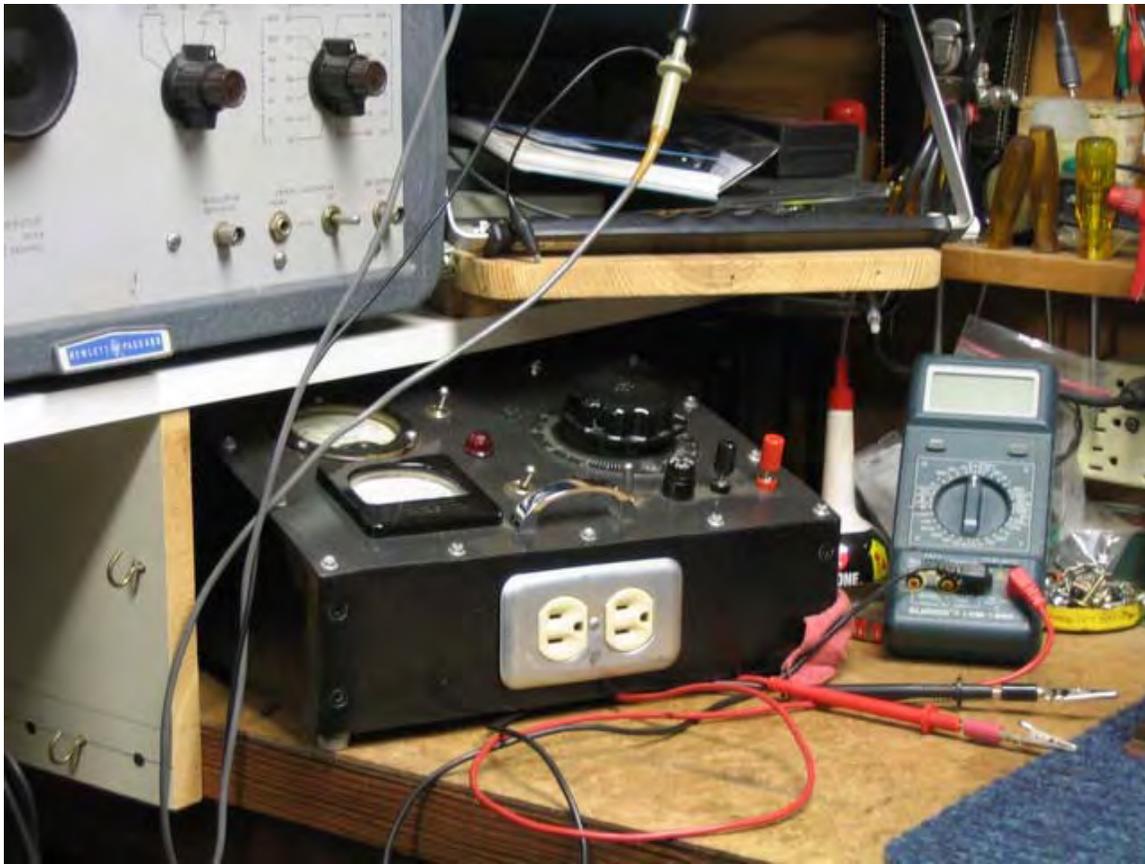
Figure 4: Homebuilt Variac control unit and Elenco digital meter

Every article on radio repair emphasizes the need for using isolation transformers and Variacs when repairing radios. Bob's main unit can be seen in Figure 4 and includes a Variac and a 500-watt isolation transformer tucked up under the shelf. A modern, and very useful piece of test equipment, can also be seen in this figure – the Elenco LCM 1950 digital Multimeter. The meter measures volts, amps, capacitors, resistors and inductance. It's a handy device which is used often when repairing radios.
